# QUALIFICATION TESTING OF THE BDU-12/B PRACTICE BOMB

TECHNICAL REPORT NO. AFSWC-TR-68-19

October 1968

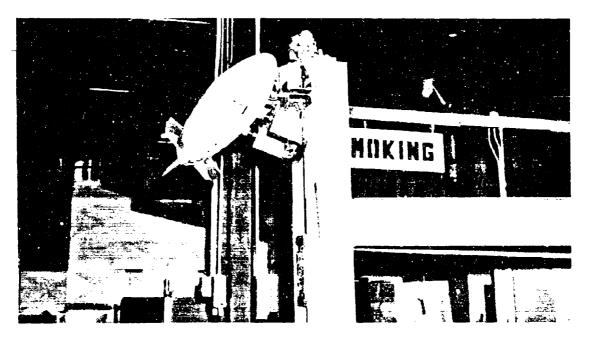
Figure 3. Typical Shock Test Setup

The required shock test is specified in method 516, Procedure 1 of MIL-STD-810A. This requirement is a slope-front sawtooth input of 20-g magnitude and a duration of 10 ms. This input is applied three times, first in one direction and then in the other, along the three mutually perpendicular axes for a total of 18 shocks. The large shock test machine at the Kirtland AFB facility is a home-built steel frame which is dropped onto a lead pig. The test item is mounted to a simulated bomb rack which, in turn, is affixed to the shock tester as shown in figure 3.
